CLIENT: **Wall Panel Systems, Inc.**
421 Business Center Court
Redlands, CA 92373
909-307-8888

Test Report No: RJ4204-1

TEST REQUESTED: Uniform Load Test per ASTM E 330/ E 330M-14, *Standard Test Method for Structural Performance of Exterior Windows, Doors, Skylights and Curtain Walls by Uniform Static Air Pressure Difference.*

UNIFORM LOAD TEST PER ASTM E 330

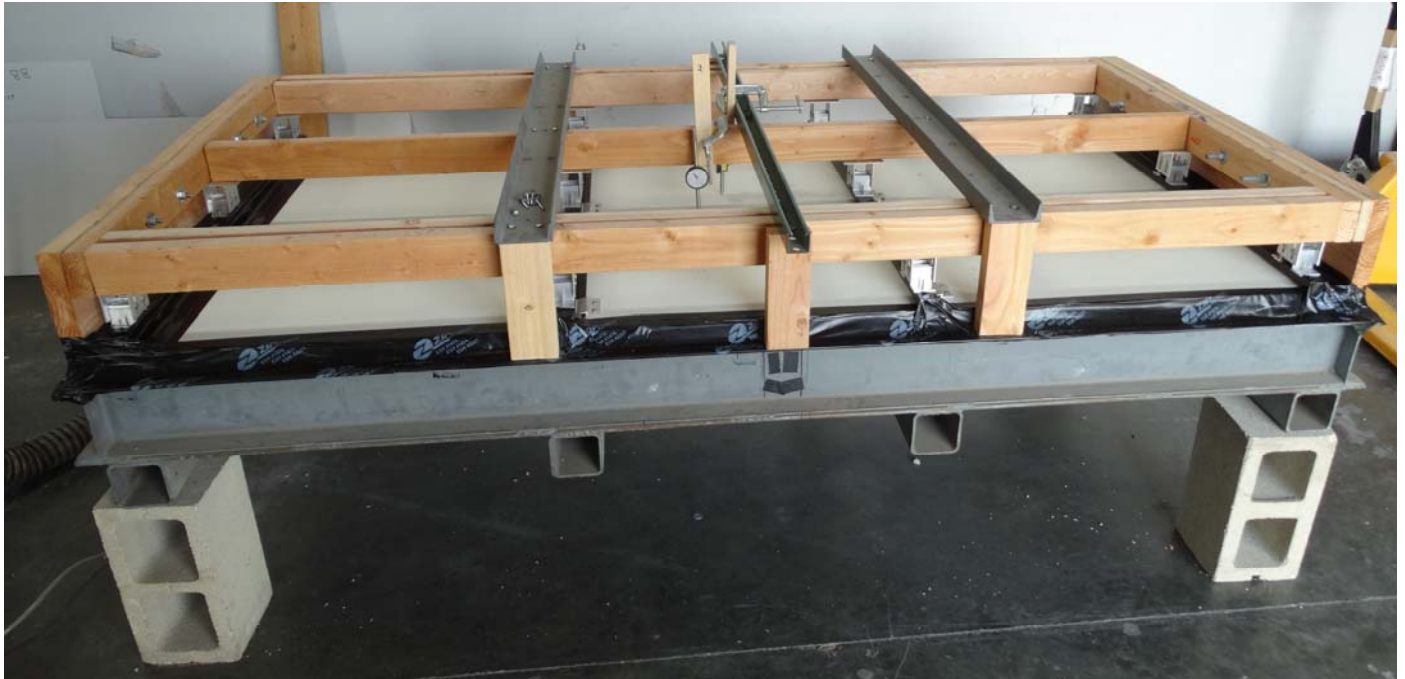
Photograph No.1
ES-500 negative load test setup.

For negative load tests, an up-lift load was applied uniformly to the interior side of the test assembly through 6-mil thick plastic bag using the same reversible controllable blower system.

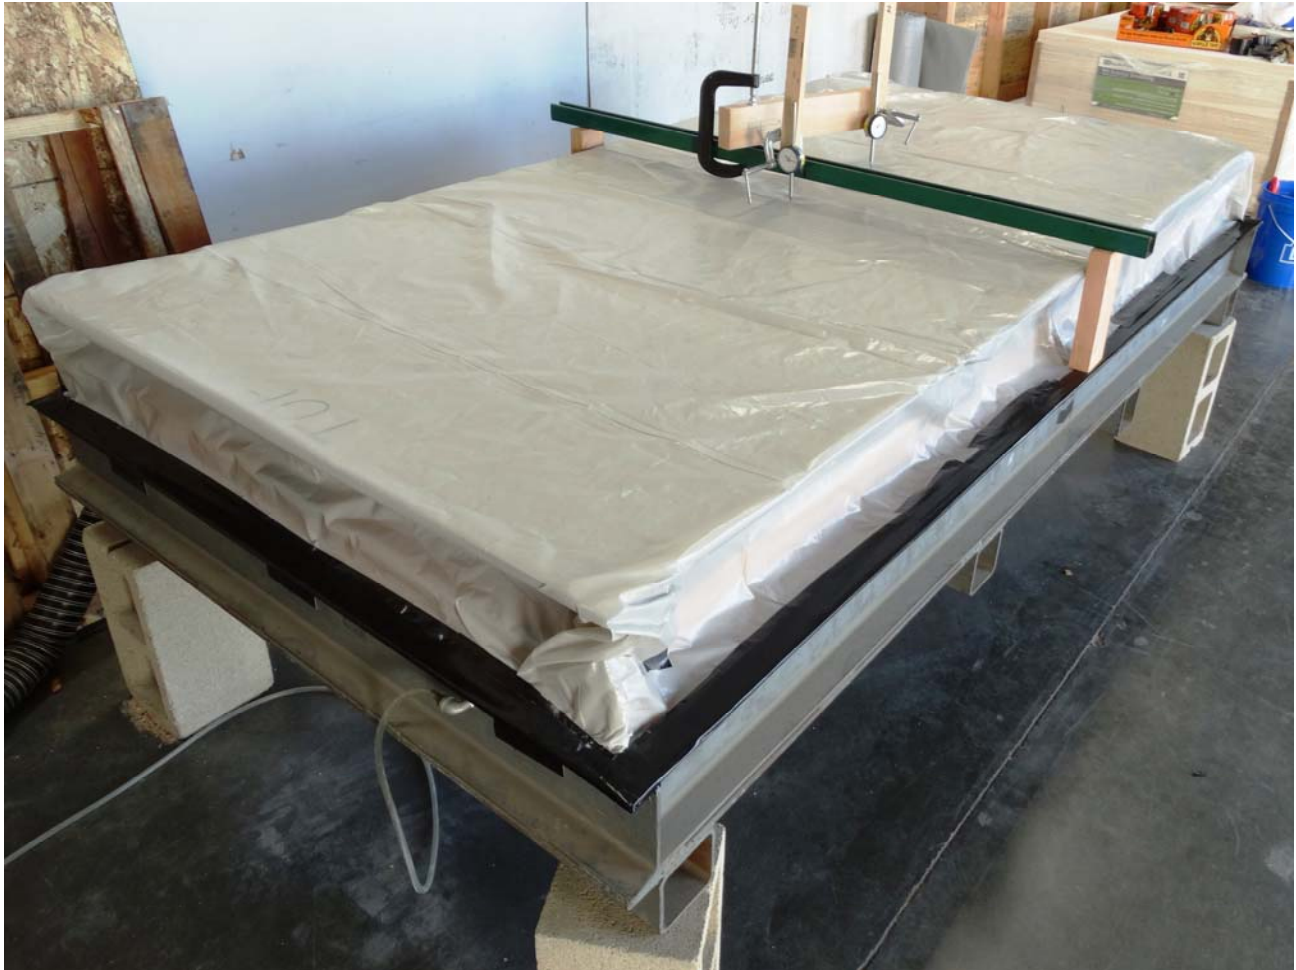
Photograph No.2
ES-500 positive load test setup.

For positive load tests, 6-mil thick plastic was placed over the exterior side of the test assembly and using a reversible controllable blower system, a vacuum applied to the test chamber.

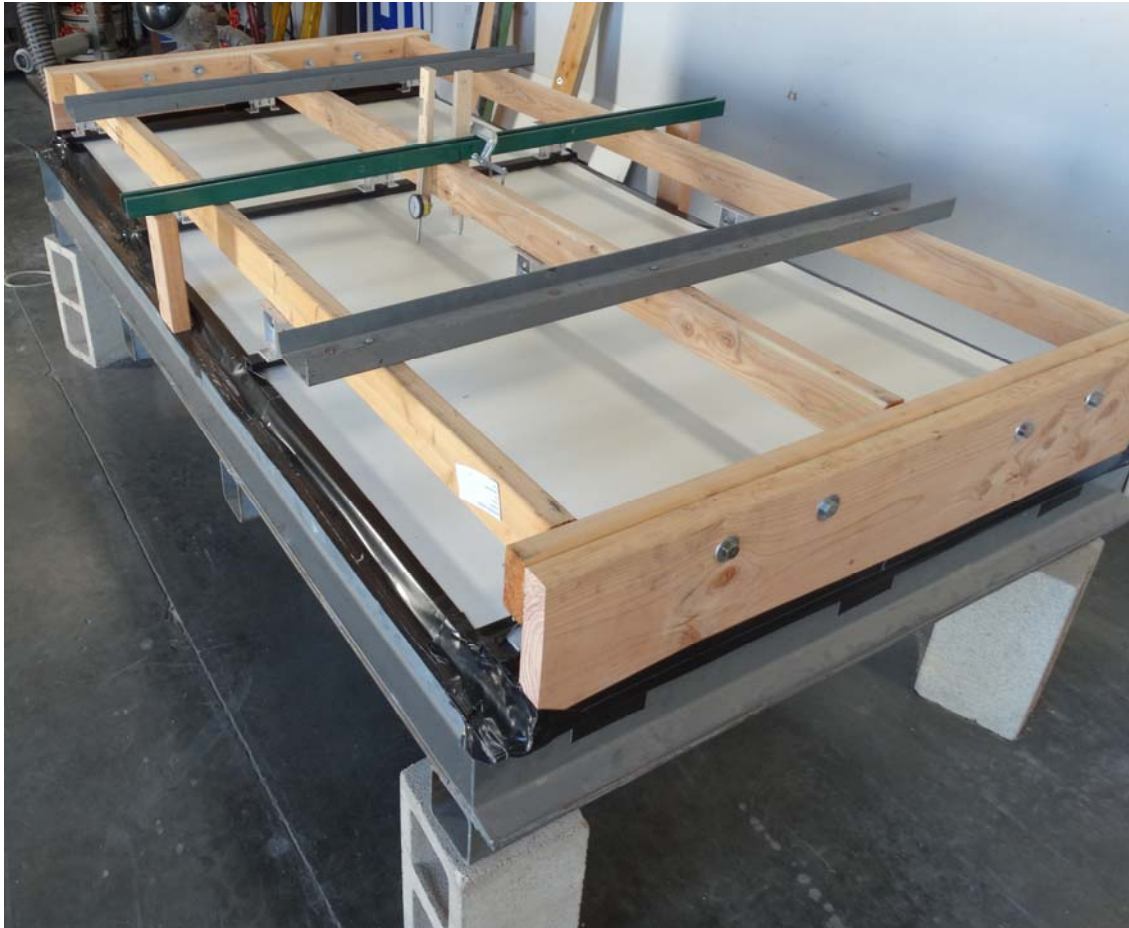
Photograph No.3
ES-400 negative load test setup.

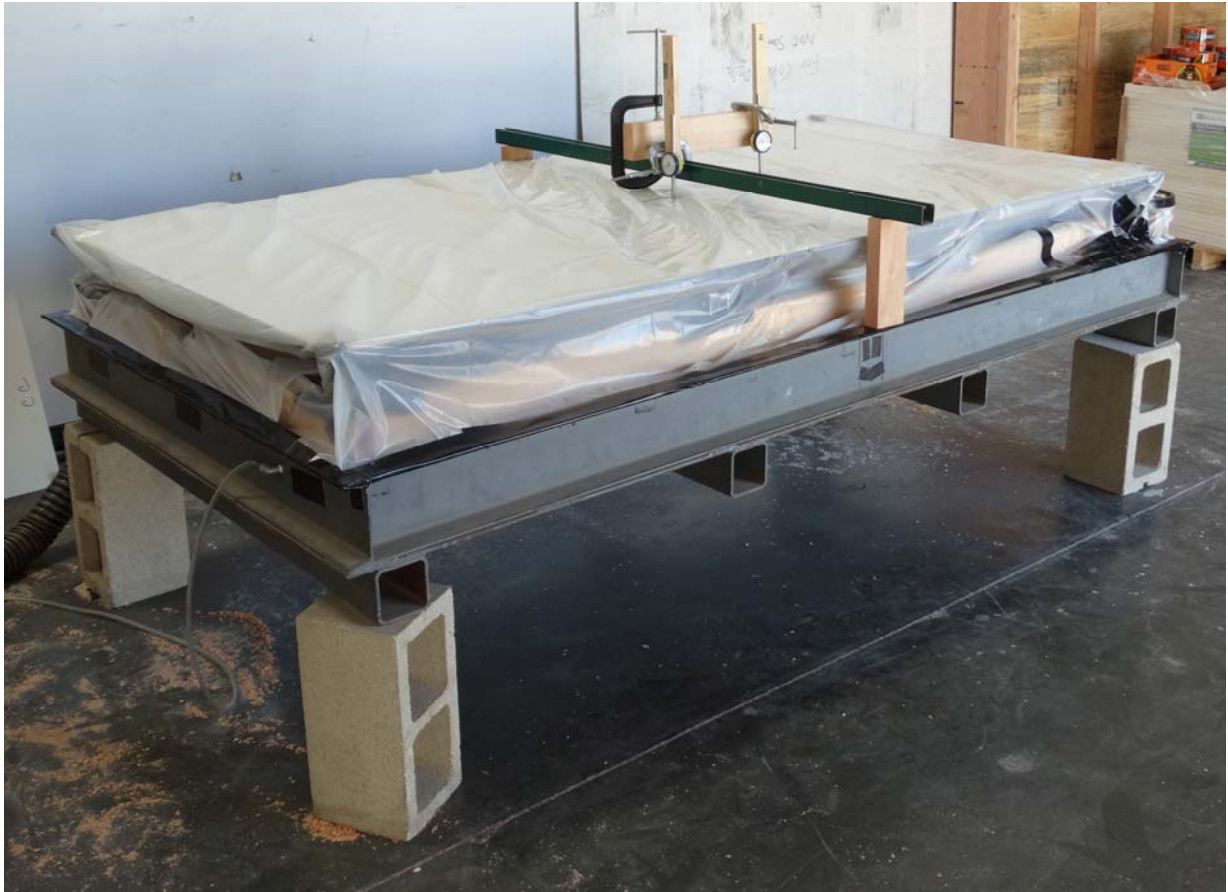
Photograph No.4
ES-400 positive load test setup.

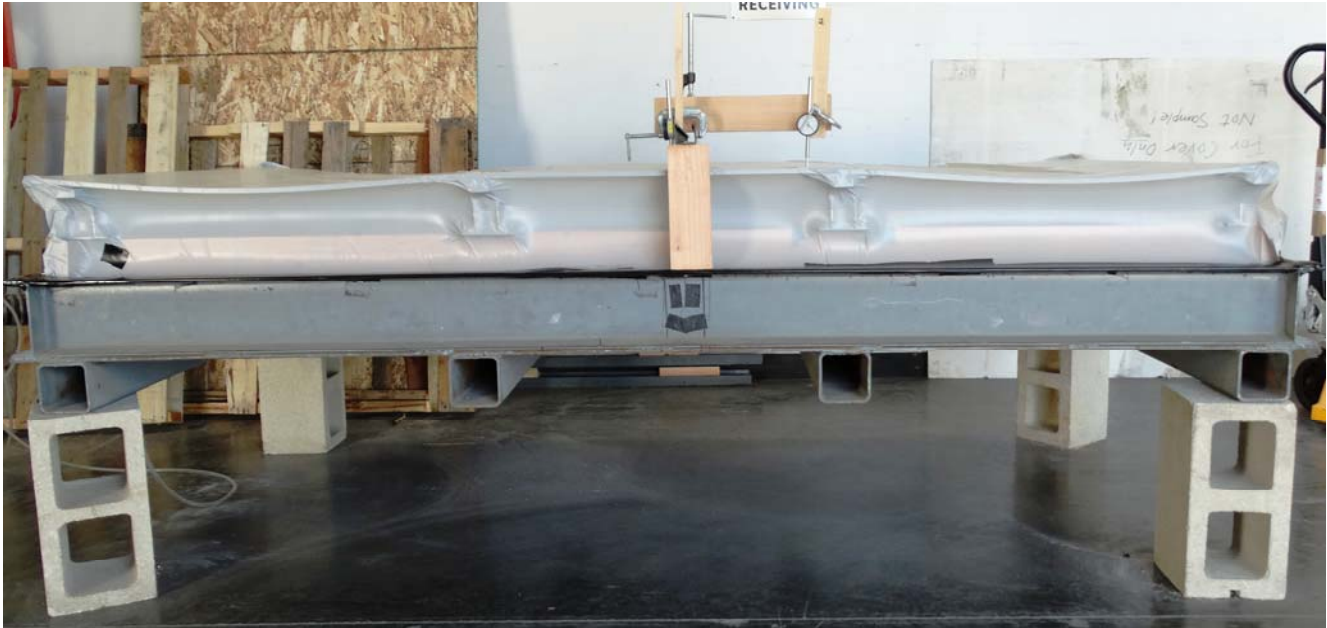
Photograph No.5
ES-500 positive load test

All three specimens withstood a test load of 210 psf without failure. No damage to the aluminum brackets or edge trim was observed. All fasteners remained intact.

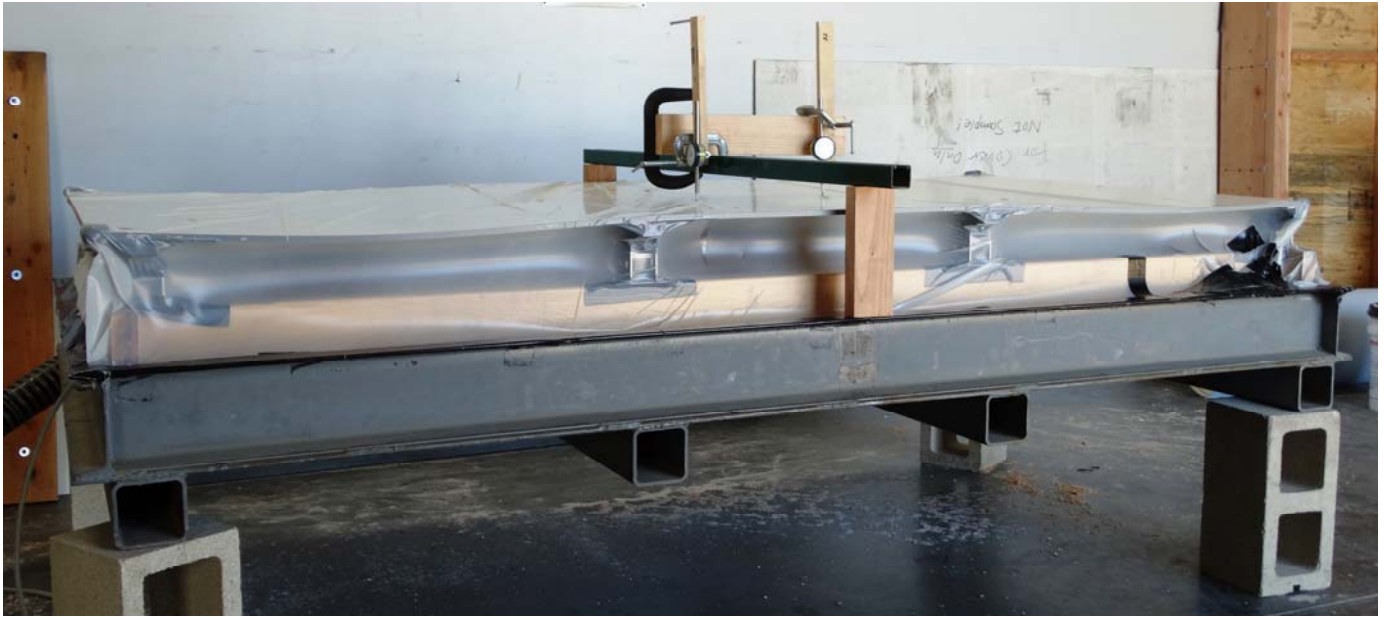
Photograph No.7
ES-400 positive load test

All three specimens withstood a test load of 210 psf without failure. No damage to the aluminum edge trim was observed. All fasteners remained intact.

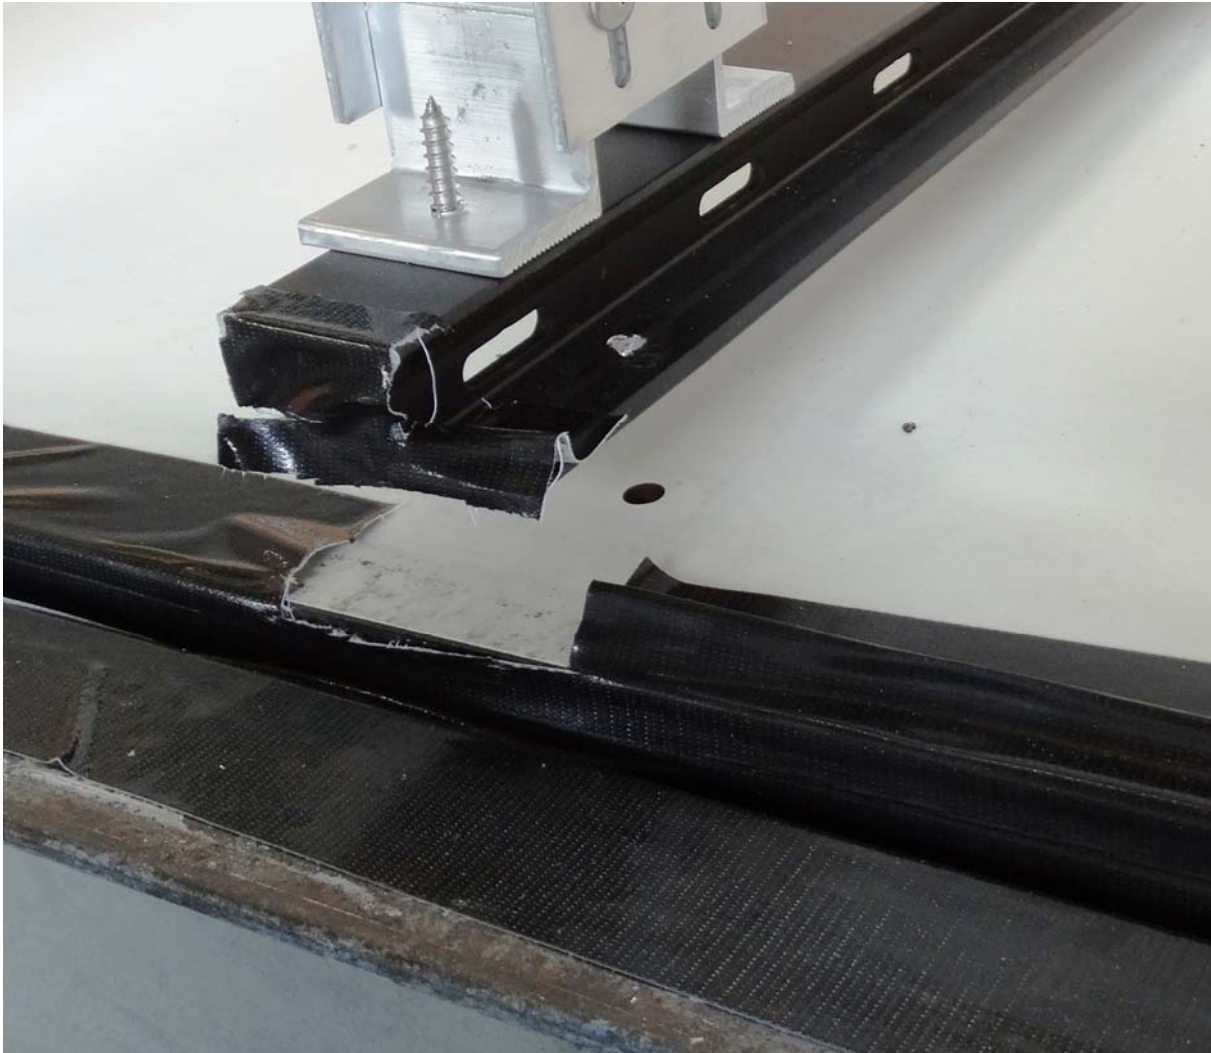
Photograph No.8

Typical results on negative load test on ES-400 cladding systems.
The through-face panel fasteners (screws) pulled out of the aluminum edge trim

At an ultimate test load of 109 psf, the through-face panel fasteners (screws) pulled out of the aluminum edge trim. No damage to the aluminum edge trim was observed.

At an ultimate test load of 99 psf, the through-face panel fasteners (screws) pulled out of the aluminum edge trim. No damage to the aluminum edge trim was observed.

At an ultimate test load of 104 psf, the through-face panel fasteners (screws) pulled out of the aluminum edge trim. No damage to the aluminum edge trim was observed.
